AN EXCELLENT IMPRESSION

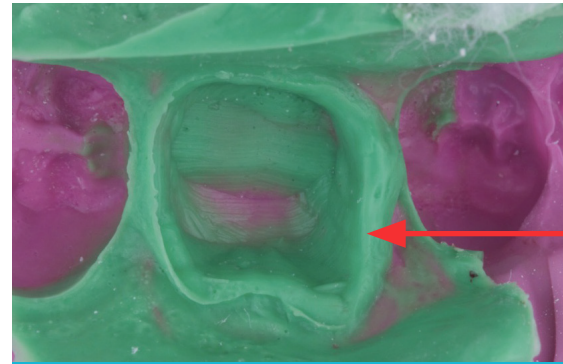
INADEQUATE MARGINS

Probable Causes:

- Incomplete sulcular expansion around the preparation
- Improper moisture control around the preparation
- Exceeding the material's working time
- Tray movement after seating

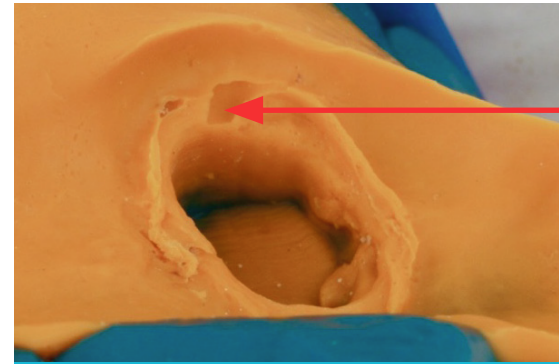
VOIDS

Probable Causes:

- Improper syringe technique
- Sulcular fluid/bloods/contaminants
- Incomplete sulcular expansion around the preparation
- Tray incorrectly seated
- Insufficient preparation covered by the impression material

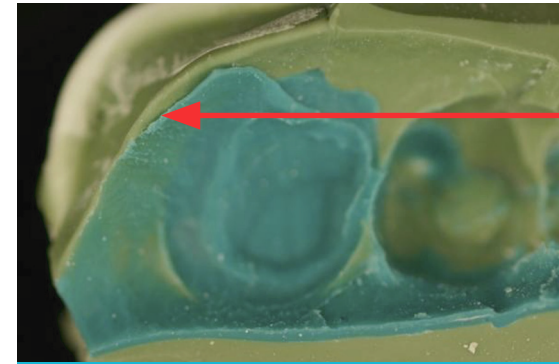
DEBONDING

Probable Causes:

- Exceeding the material's working time
- Contamination of tray material
- Impression material stored at a temperature above manufacturer's recommendation

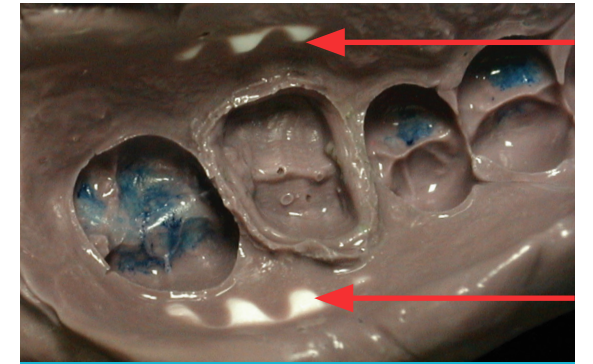
TRAY CONTACT

Probable Causes:

- Incorrect tray size used
- Tray not oriented correctly
- Insufficient impression material used

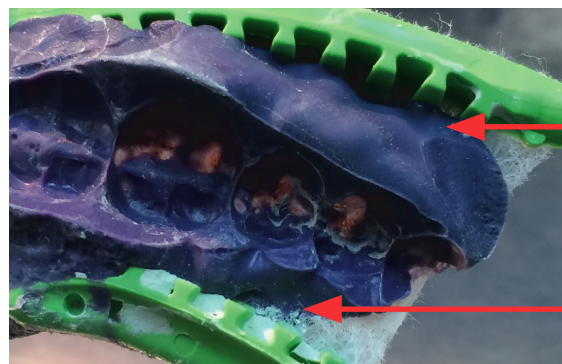
INADEQUATE IMPRESSION RETENTION

Probable Causes:

- Insufficient impression material used
- No tray adhesive used
- Inadequate tray adhesive drying time
- Outdated impression material used

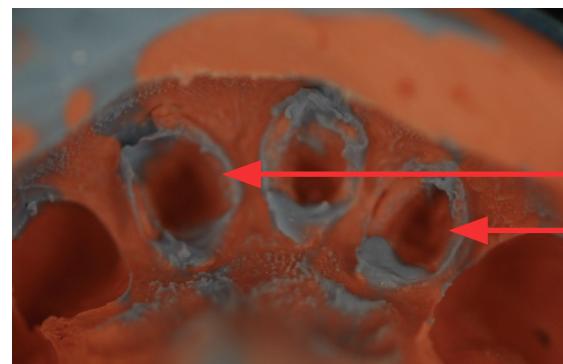
TEARING OF WASH MATERIAL

Probable Causes:

- Insufficient retraction around the preparation
- Impression removed before material has set
- Improper moisture control around the preparation
- Outdated impression material us

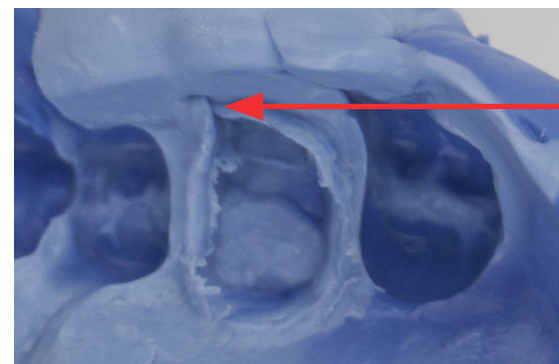
PULLS

Probable Causes:

- Exceeding the material's working time
- Tray movement after seating the impression
- Insufficient impression material used
- Rapid seating of the impression tray

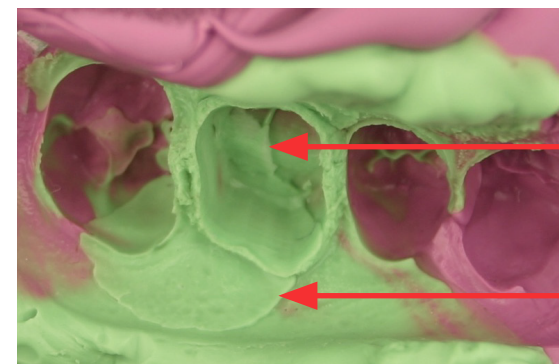
LEDGES

Probable Causes:

- Preparation of most posterior tooth is contraindicated with dual-arch trays
- Buccal, lingual and posterior tray contact
- Lack of occlusal clearance
- Extreme mesh exposure

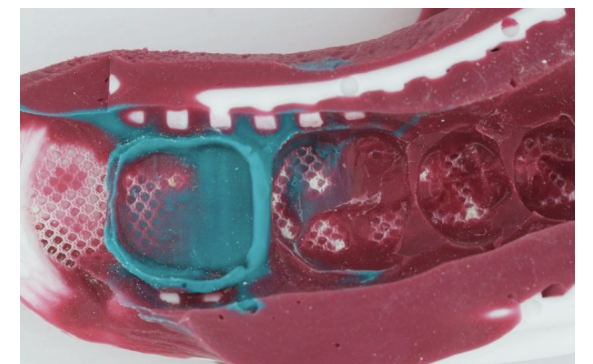
TRAY ISSUES

Probable Causes:

- Incomplete sulcular expansion around the preparation
- Improper moisture control around the preparation
- Exceeding the material's working time
- Tray movement after seating
